**FLIGHT SERVICE EVALUATION
OF COMPOSITE COMPONENTS ON THE
BELL HELICOPTER MODEL 206L**

**SECOND ANNUAL FLIGHT SERVICE REPORT
AUGUST 1983 THROUGH DECEMBER 1985**

**BELL HELICOPTER TEXTRON, INC.
FORT WORTH, TEXAS 76101**

**CONTRACT NAS1-15279
AUGUST 1986**

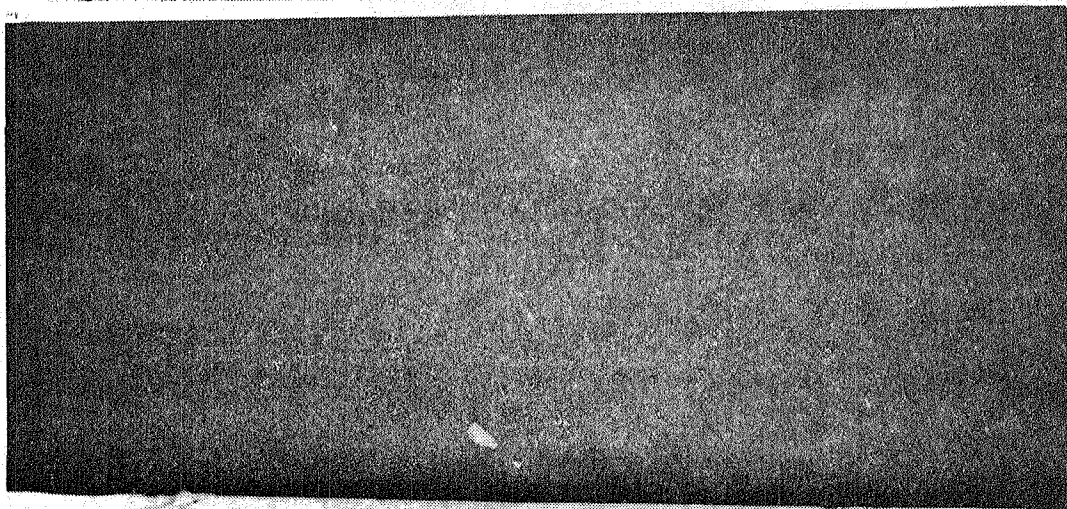
Of the four components, the baggage door has the poorest record of service. The adhesive used in the Kevlar doors has not maintained its integrity. There were several cases of a large number of voids in the door. One reason that added to the problem was the fact that the outside face sheet was co-cured with nomex core. There was very little adhesive present between the nomex core and the fuse sheet. This left a poor bond between the outside skin and the core. Figure 2-1 is a picture of a door that was struck under "normal operating environment" in the New York City area. Figure 2-2 shows cracks in the laminate. A close examination of the door yielded large areas of disbond between the outer face and the core. This door is of the same manufacturing lot that was tested after one year of service. The previous report said the door failed prematurely and it might be due to the year of service. It is believed, now, that it was due strictly to a poor resin and

Figure 2-2. Cracks in the laminate of the baggage door.

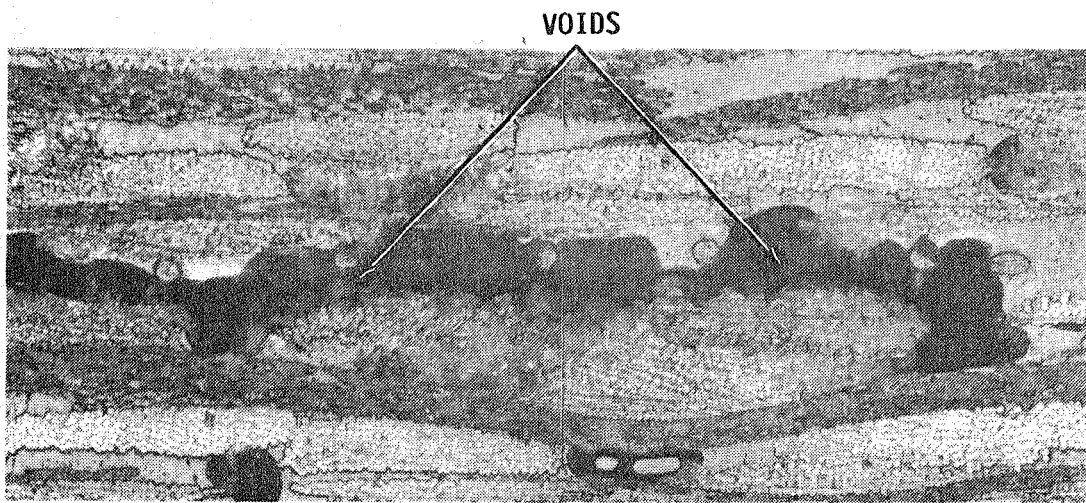
poor construction. Figure 2-3 is a 100X photo of a cross section of the laminate through the door. There are large areas of voids indicated on the photographs.

Figure 2-3. 100x magnification of a cross section of the laminate through the door.

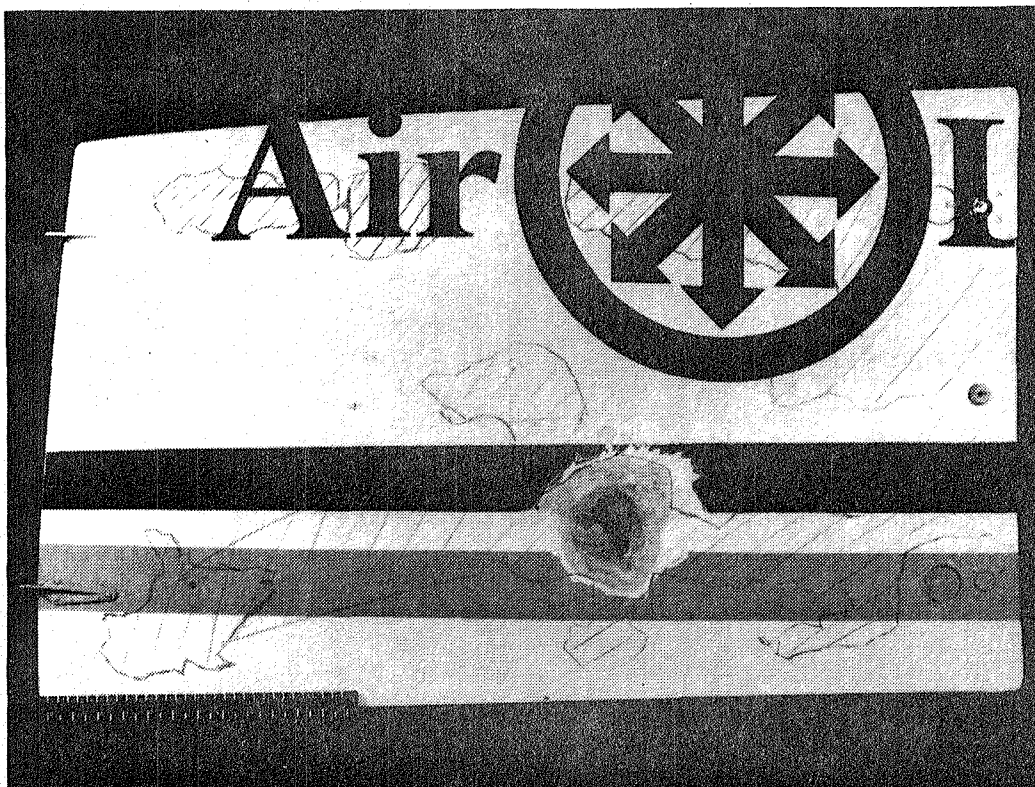
Another baggage door was returned due to delaminations between the core and the exterior skin. It is shown in Figure 2-4. A repair at the operator's facility was attempted by identifying the voids, and then using a grinding wheel to remove the skin. The technician was then going to repair the door with a fiberglass patch. After he had frayed the skin, he discovered other areas of disbond. He then marked the zones and sent it back to Bell. Figure 2-5 shows the voids on the composite door.

Figure 2-4. Baggage door returned due to delaminations.

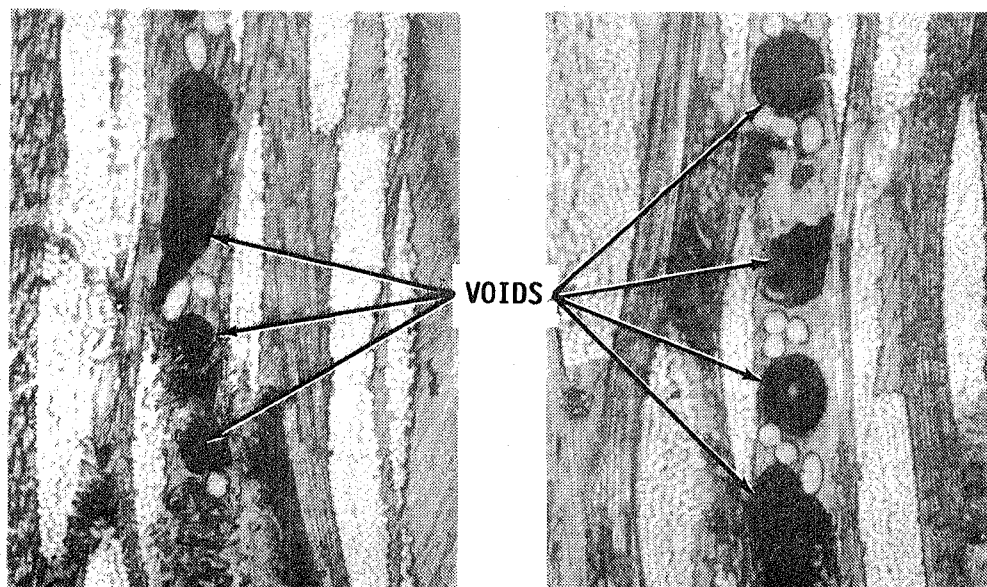
Figure 2-5. Voids on the composite door.

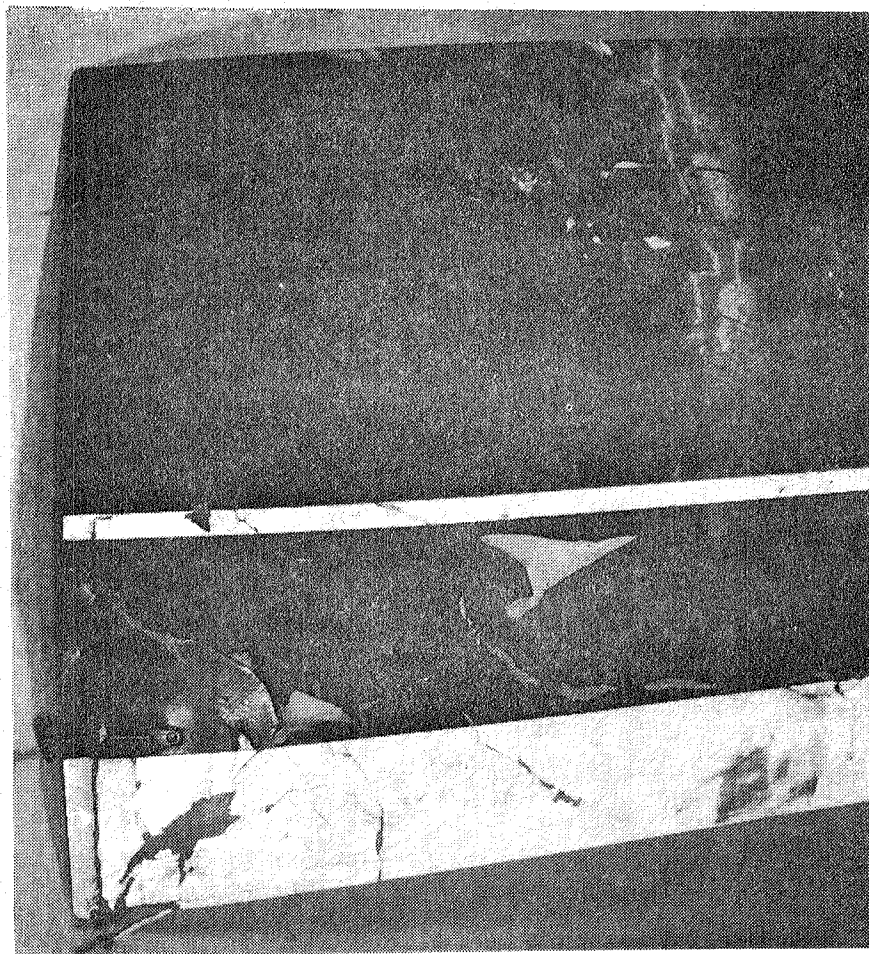
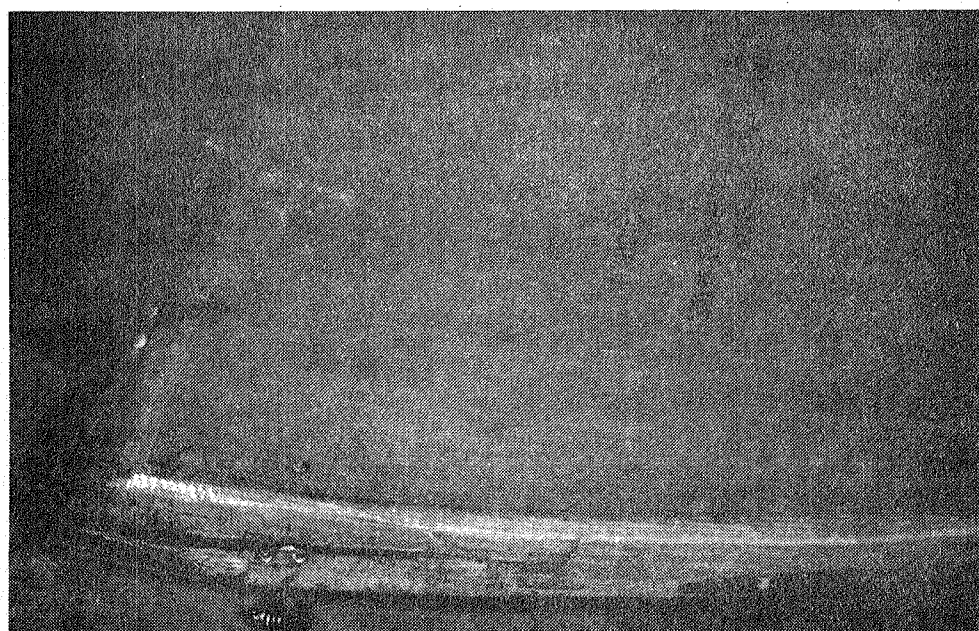
A baggage door was destroyed in a hard landing when a helicopter rolled into a ravine. Figures 2-6 and 2-7 show the damaged baggage door.

Figure 2-6. Baggage door damaged due to a hard landing.

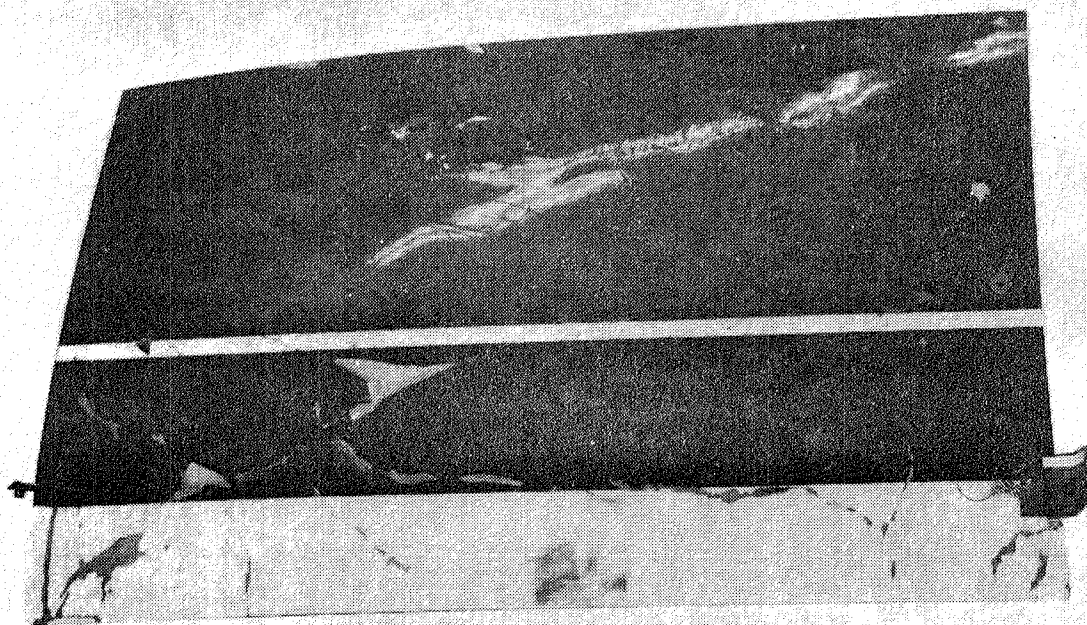
Figure 2-7. Damage to baggage door caused by a hard landing.

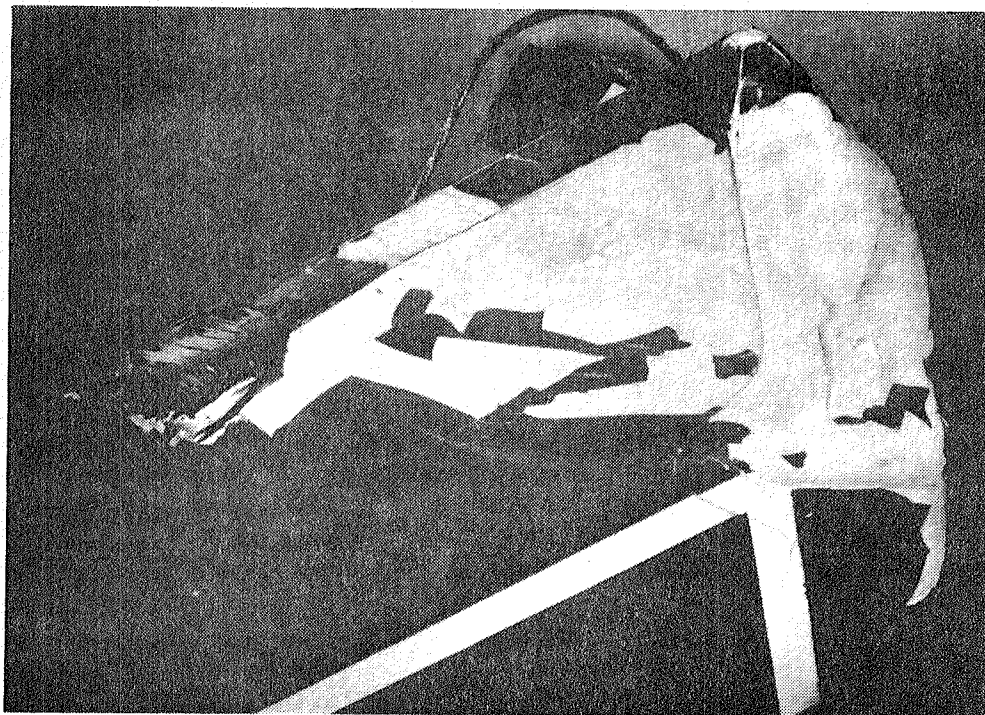
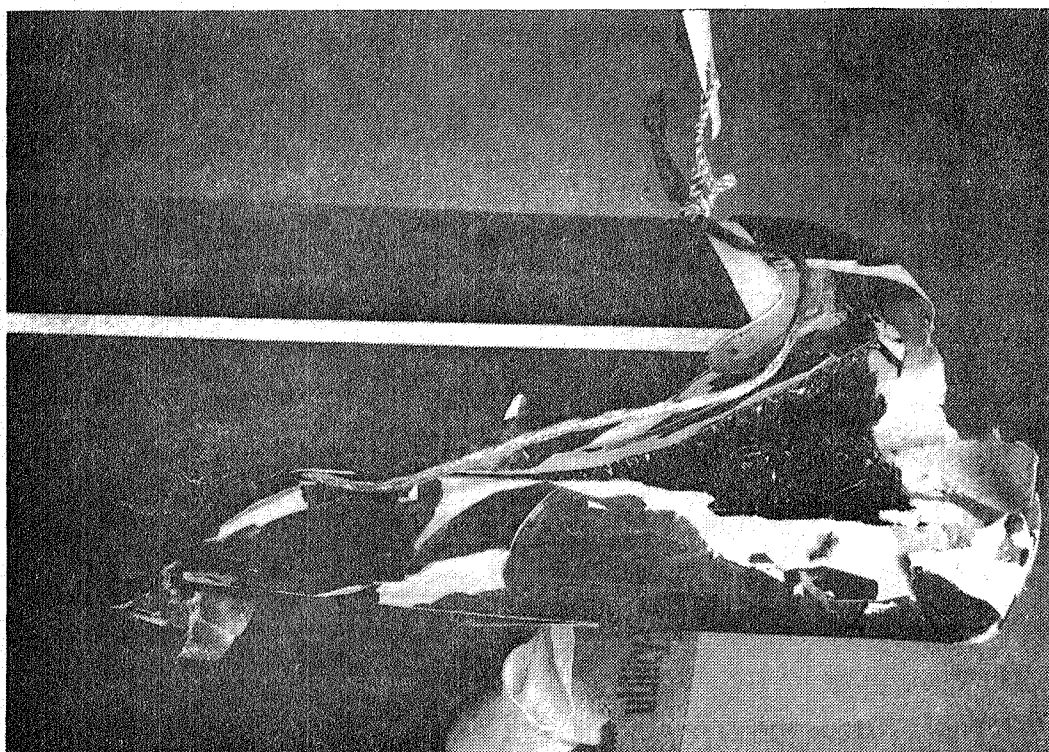
One fin was destroyed in the same hard landing mentioned in Section 2.3 when a helicopter rolled into a ravine. Figures 2-8 and 2-9 show the damage to the fin. The forward fairing and litter door were undamaged.

Figure 2-8. Fin damaged during hard landing.

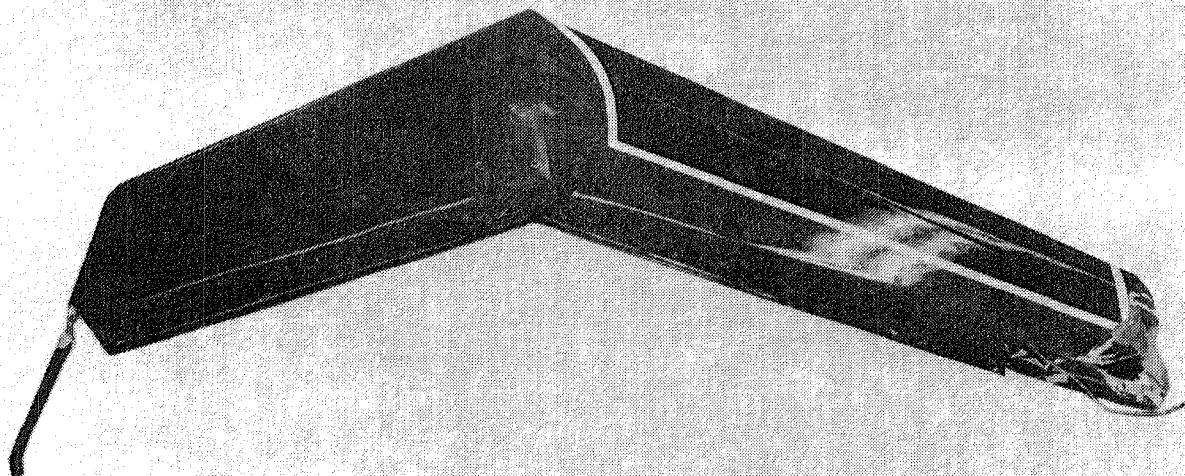
Figure 2-9. Damage to fin caused by a hard landing.

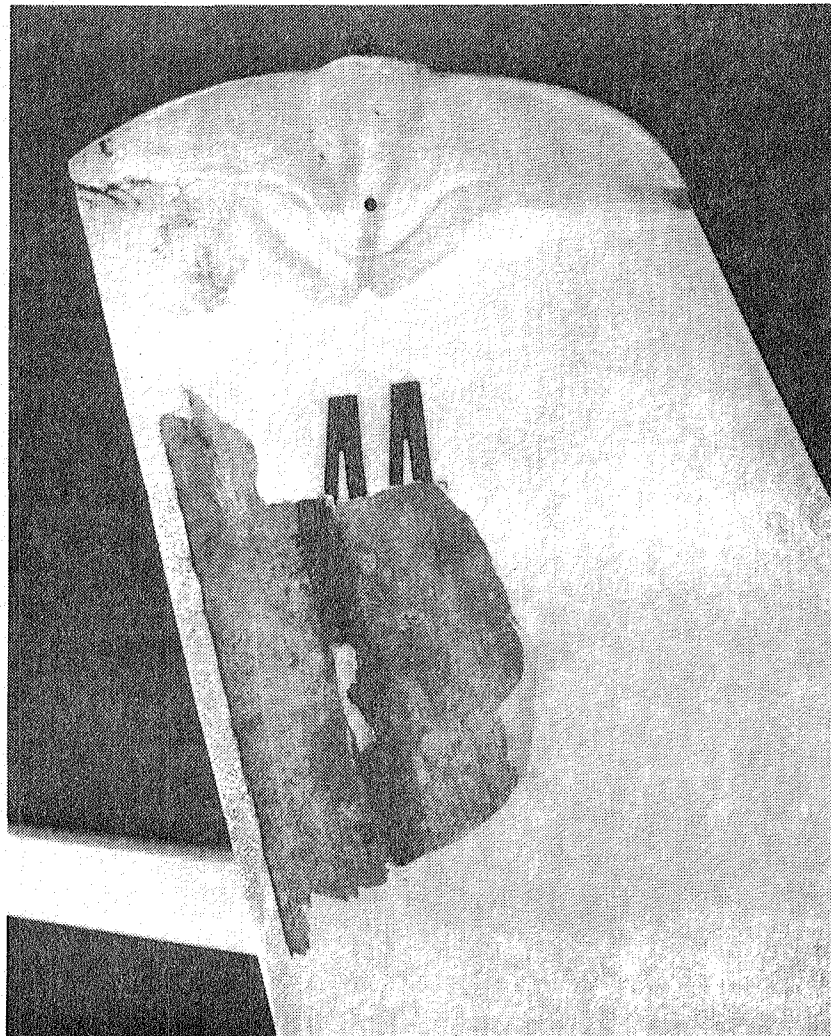
An inspection of the fin did not show any laminate delamination, but rather a peeling of the paint and a corrosion of the wire mesh used for lightning protection. Closer examination showed evidence that an electrical charge had been transmitted through the fin and exited at the fin to tailboom attachment locations. It was determined at that time that the fin had been struck by lightning.

Figure 5-1. Corrosion on the wire mesh on the fin struck by lightning.

to separate the wire mesh and the graphite. Instead, the adhesive was applied on the outside of the mesh between the mesh and the paint. Had the FM1000 been correctly applied, the corrosion might not have occurred and the fin could have been easily repaired.

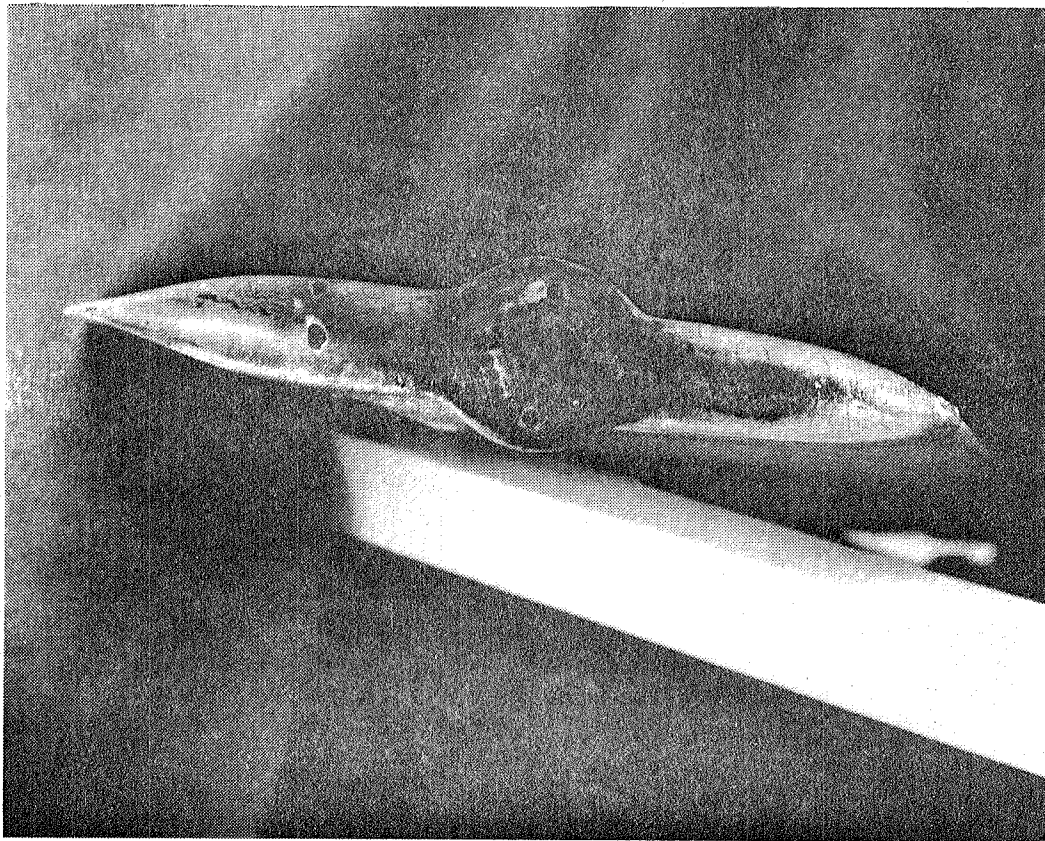
Figure 5-2. Charred top of fin struck by lightning.

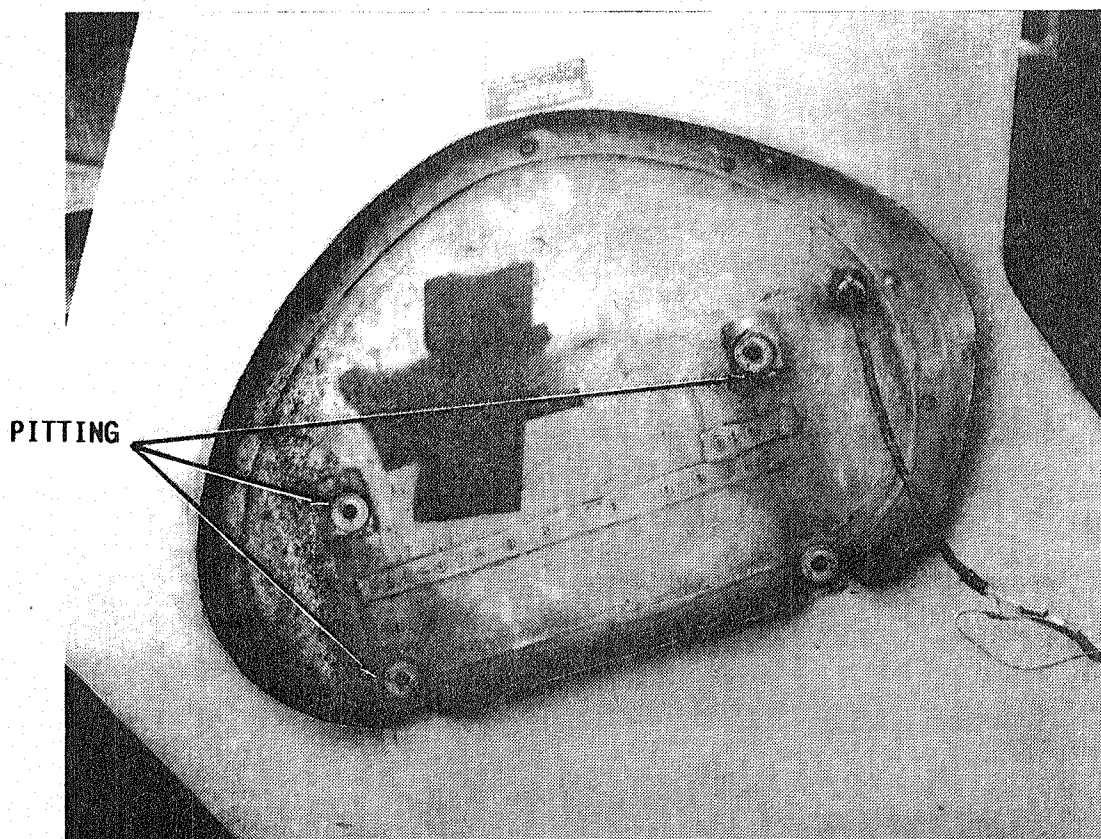
Figure 5-3. Tailboom attachment fittings of fin struck by lightning.

The fasteners were examined and the pitting was determined to be caused from electric arcing. No other effects or degradation were found with the fasteners.

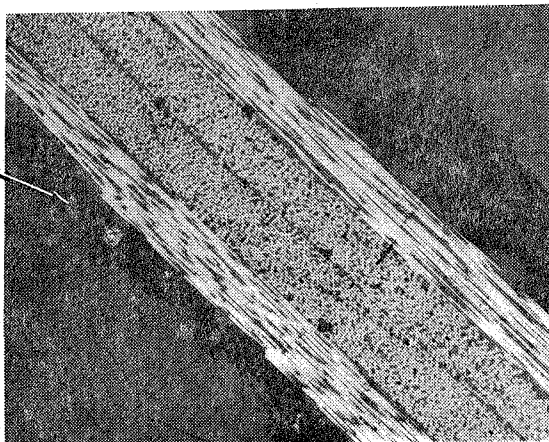
A. Damaged Area 100x

Figure 5-6 shows a 100X photograph of a cross section of the damaged and undamaged laminate. The laminates were of a different orientation and number of plys. The only degradation noticable on the photographs is the wire mesh which had corroded.

Figure 5-6. 100X magnification of a cross section of the damaged and undamaged specimen.
